Gas Asset Report

CLIENT: SIREPM

Asset Report Summary

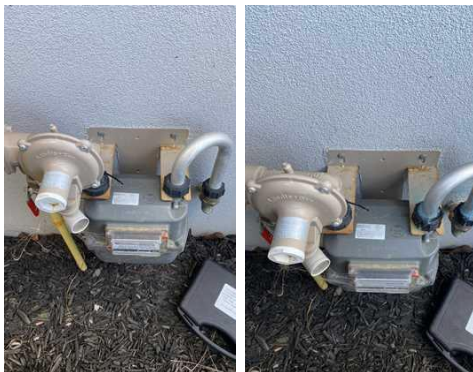
GAS FITTING LINE	
CHECKLIST	
Safely Disconnect Gas Meter & Depressurise Gas Line	YES
Ensure All Appliance Pilots Are Turned Off and Isolation Vales In Open Position	YES
Attach Suitable Test Instrument	YES
Pressurize Gas Installation To Operating Pressure Or 2kpa (Whichever Is Greater)	YES
Measure Loss Of Pressure Over 5min Period	YES
Has The Gas Fitting Line Passed The Leakage Test	YES
Bubble Test Gas Meter Connections On Completion Of Test	YES
Has All Information/Images Been Uploaded And Recorded	YES
NOTES	
PHOTO/S

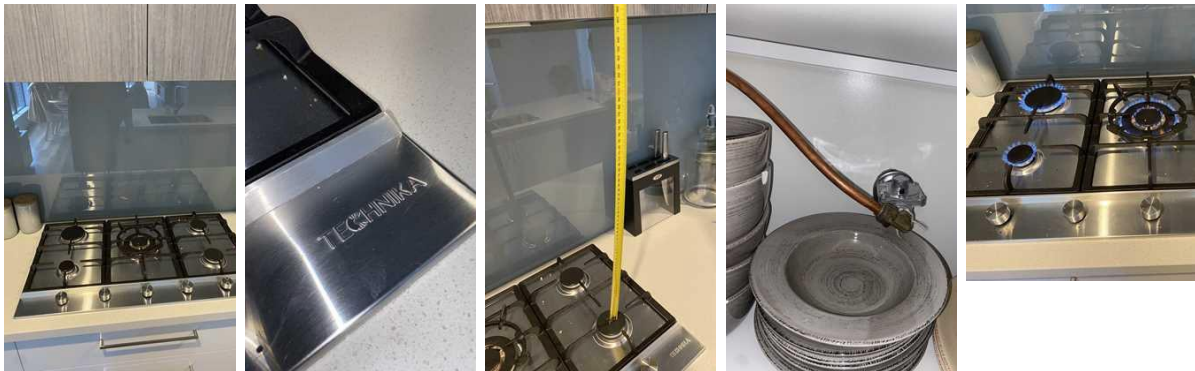
GAS COOKTOP

MAKE:	Technika		
MODEL:	TGC9GLX	YEAR:	
SERIAL NUMBER:	9882000	LOCATION:	Kitchen

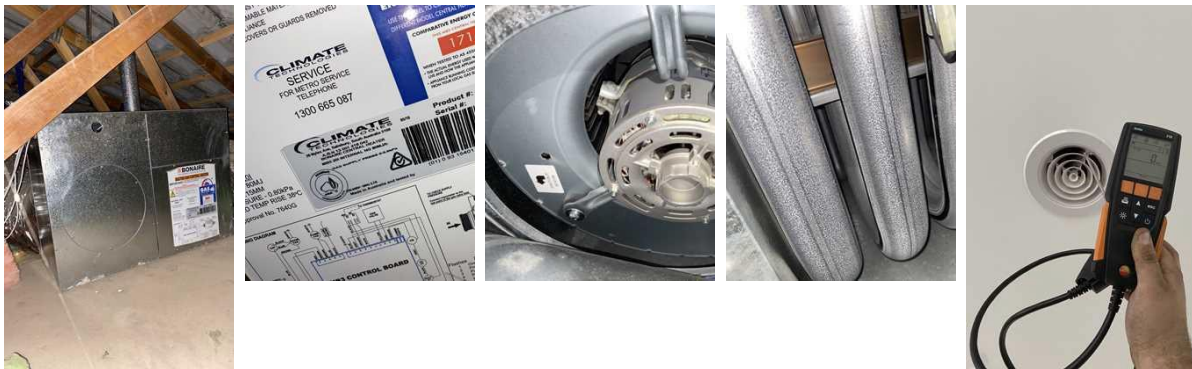
GAS DUCTED HEATER

MAKE:	Bonaire		
MODEL:	MB3 20I	YEAR:	2018
SERIAL NUMBER:	07153246	LOCATION:	Ceiling space
